PHASE I REPORT  
NATIONAL DAM INSPECTION PROGRAM

Name of Dam: HOSENSOCK DAM  
State & State No: PENNSYLVANIA, 54-168  
County: SCHUYLKILL  
Stream: HOSENSOCK CREEK  
Date of Inspection: May 8, 1979

PHASE I INSPECTION REPORT  
NATIONAL DAM INSPECTION PROGRAM

HOSENSOCK DAM

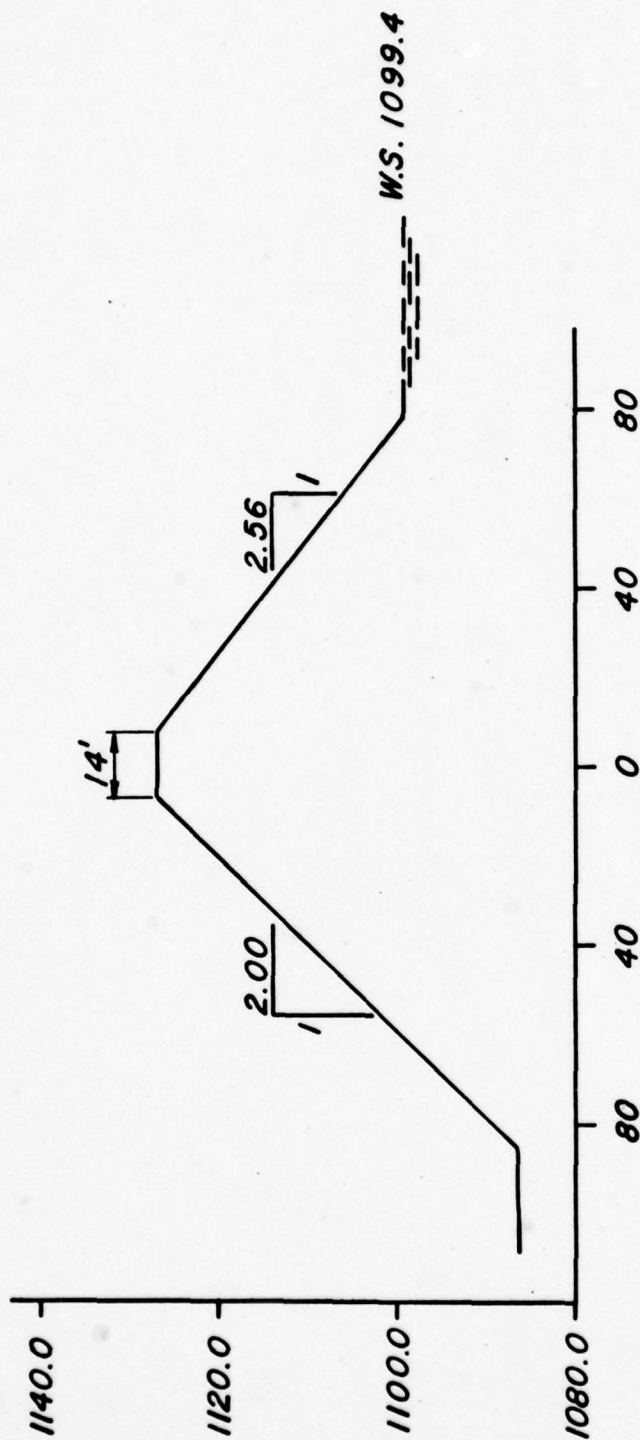
PLATE A-III

The visual inspection did not observe or detect any signs of embankment instability. The original design report indicates a minimum factor of safety of 1.52 for full drawdown condition. The slopes were surveyed to be virtually the same as designed. Refer to Appendix A, Plate A-III.

EMBANKMENT SECTION

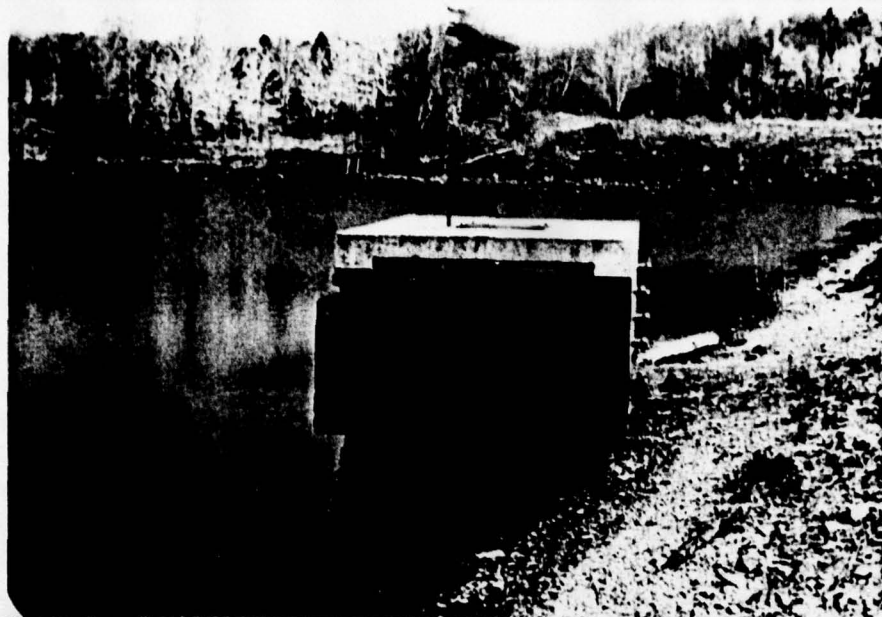
Control Structure  
"Riser"

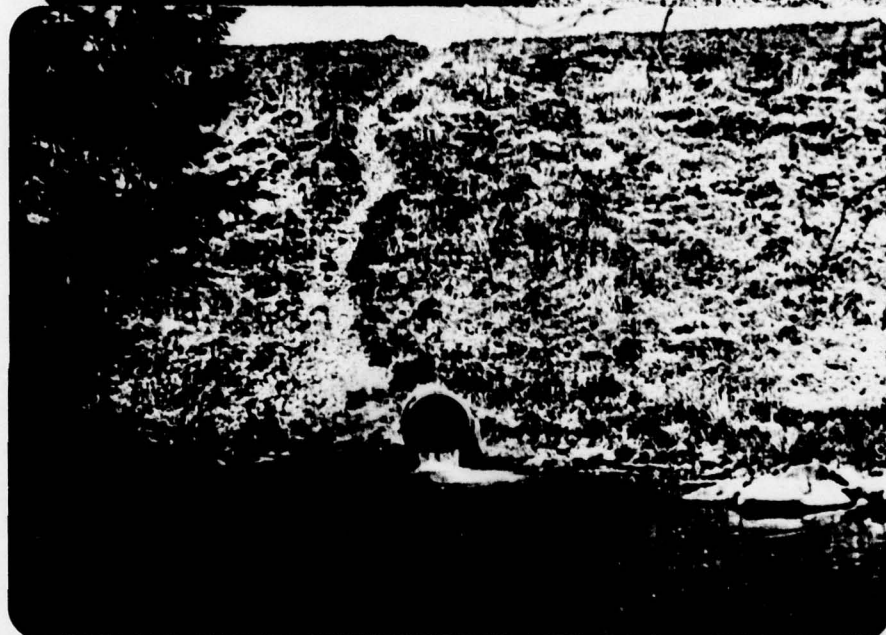
is always partially open to allow the minimum downstream flow to be maintained. According to the owner's representative, this valve has not been operated during the past seven years. The invert at the entrance to the structure is 1091.8. The next inlet is an 18-inch by 24-inch uncontrolled orifice at elevation 1099.8. The prime inlet is the weir crest at elevation 1103. Refer to Appendix F, Plate VI. The principal spillway appears to be in good condition. Water was discharging from the 30-inch diameter outlet conduit into the outlet plunge pool. The exposed portion of the concrete pipe appeared to be in good condition.

Outlet Pipe

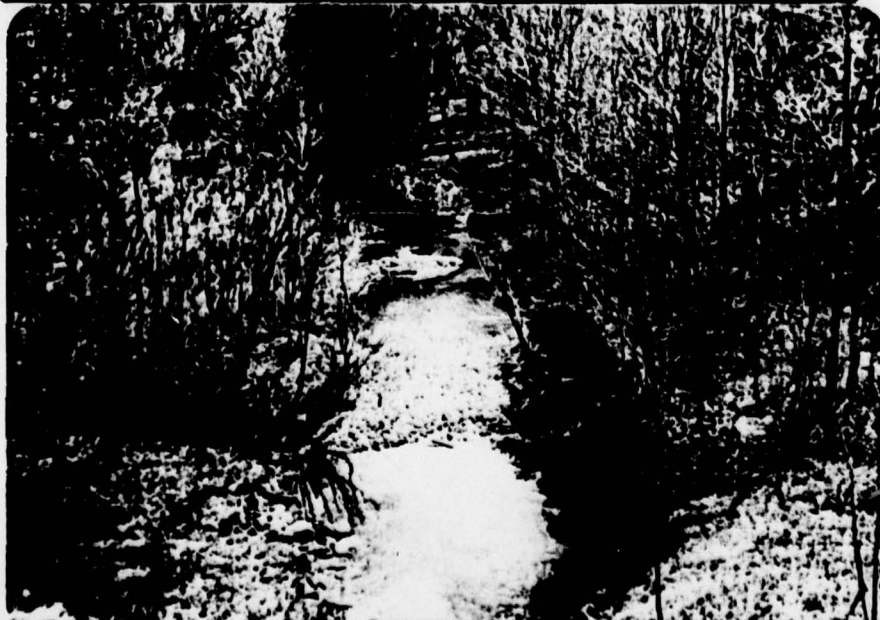
B. OUTLET STRUCTURE	30-inch diameter concrete pipe discharges directly into the natural stream channel. This discharge is from the principal spillway structure - good condition.

Downstream Channel  
Outlet Pipe

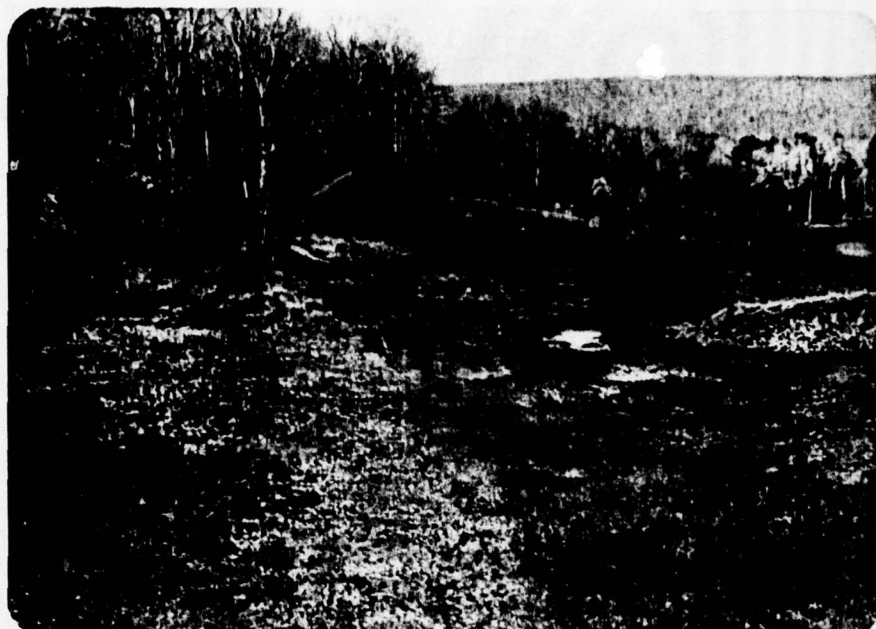
The emergency spillway is covered with a firm stand of grass. It is in very good condition and it appears that erosion will not be a problem in the event of flood flow through this area.

Forebay & Emergency Spillway
